SAMPLING ACTIVITIES/TRIP REPORT

COUNTY LINE MERCURY

Highlands Ranch, Douglas County, Colorado

TDD No. 9605-0006

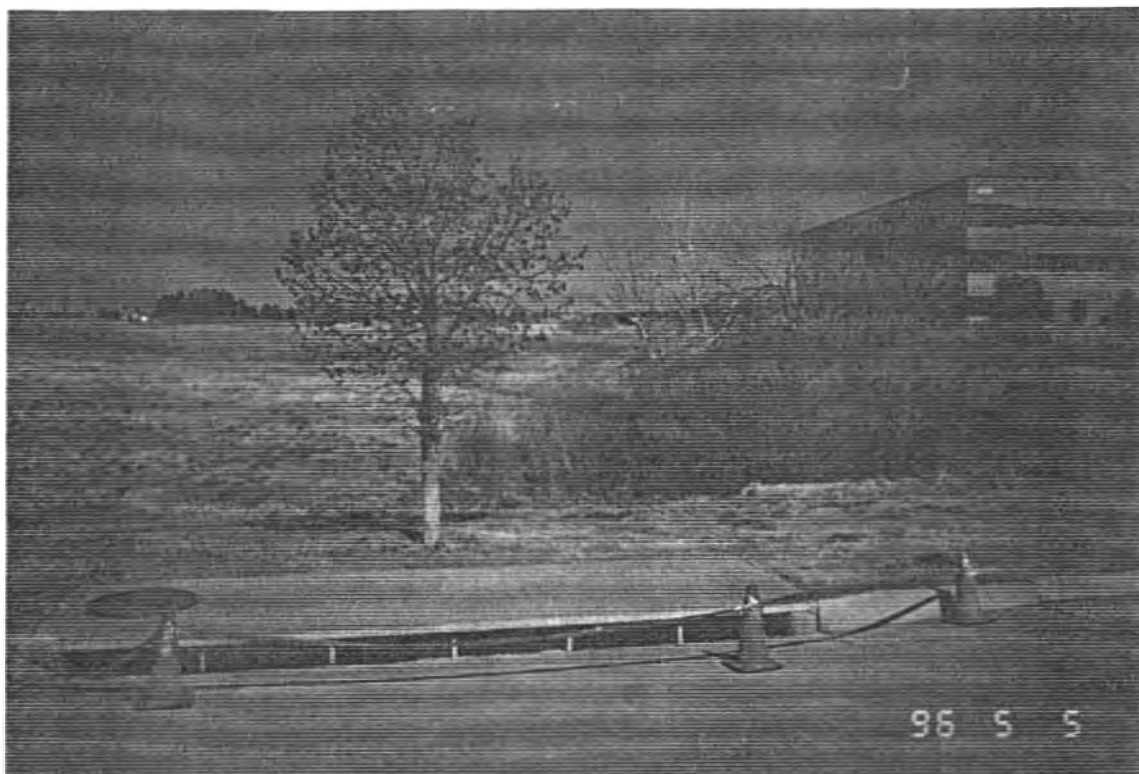
PHOTO 1

Storm sewer drain leading into storm sewer vault, looking east. The area is roped off due to mercury contamination.

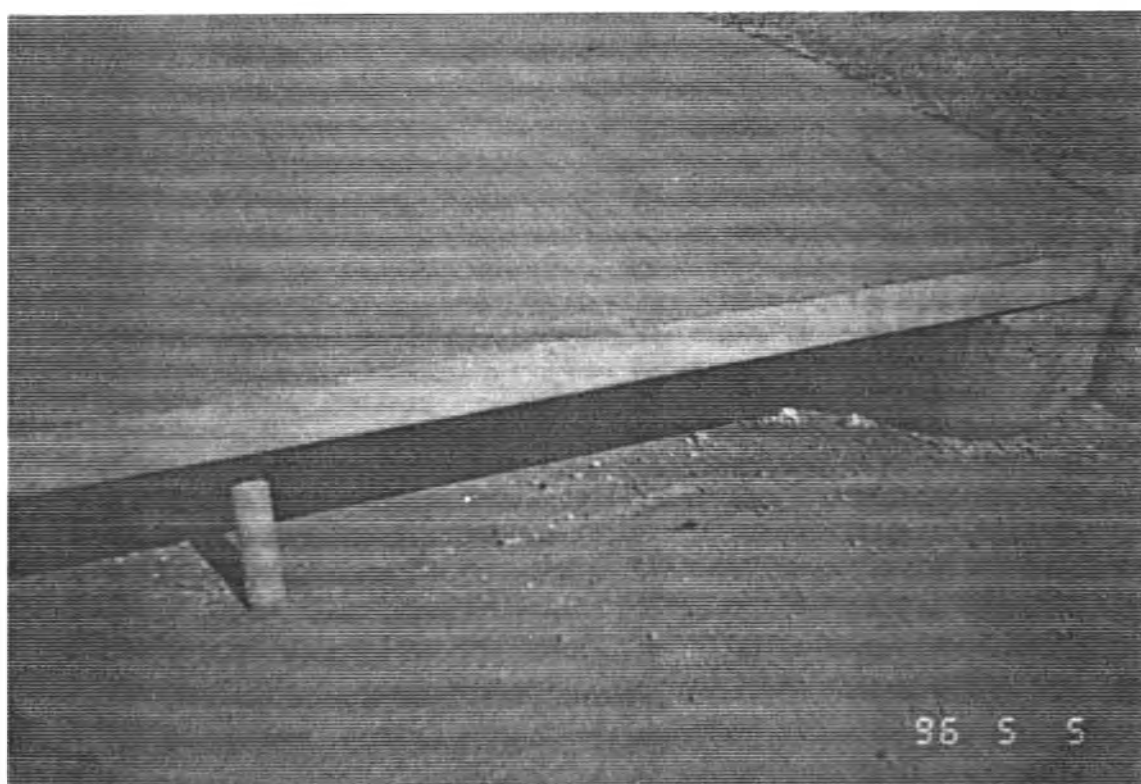
PHOTO 2

Close up of storm sewer drain with mercury beads present. Drain is located on the east side of the entrance into Bluffs Complex.

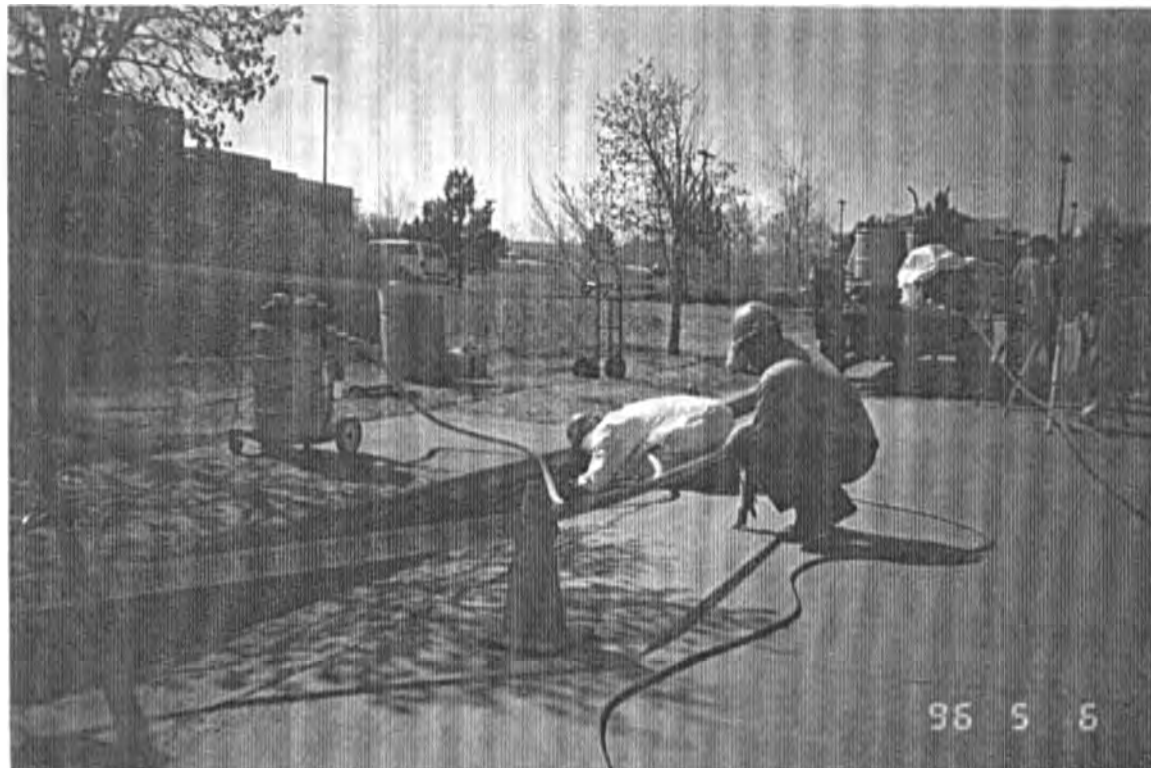
PHOTO 3

Smith/Riedel contractors cleaning up free mercury beads with a vacuum along the storm sewer drain.

In response to the release, the two residences, the concrete staircase, and the concrete storm drain were cleaned up by Smith/Riedel (Photos 3 and 4).

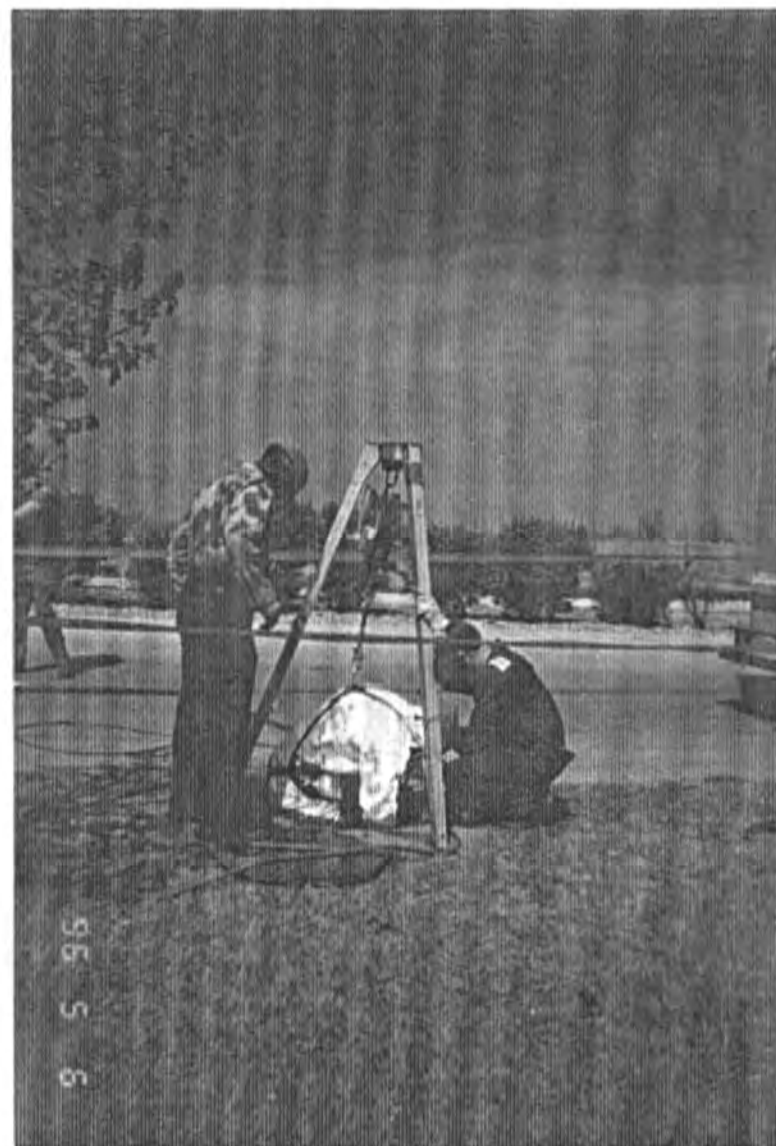
PHOTO 4

Smith/Riedel personnel performing a confined space entry into the storm sewer vault for cleanup of mercury contamination.

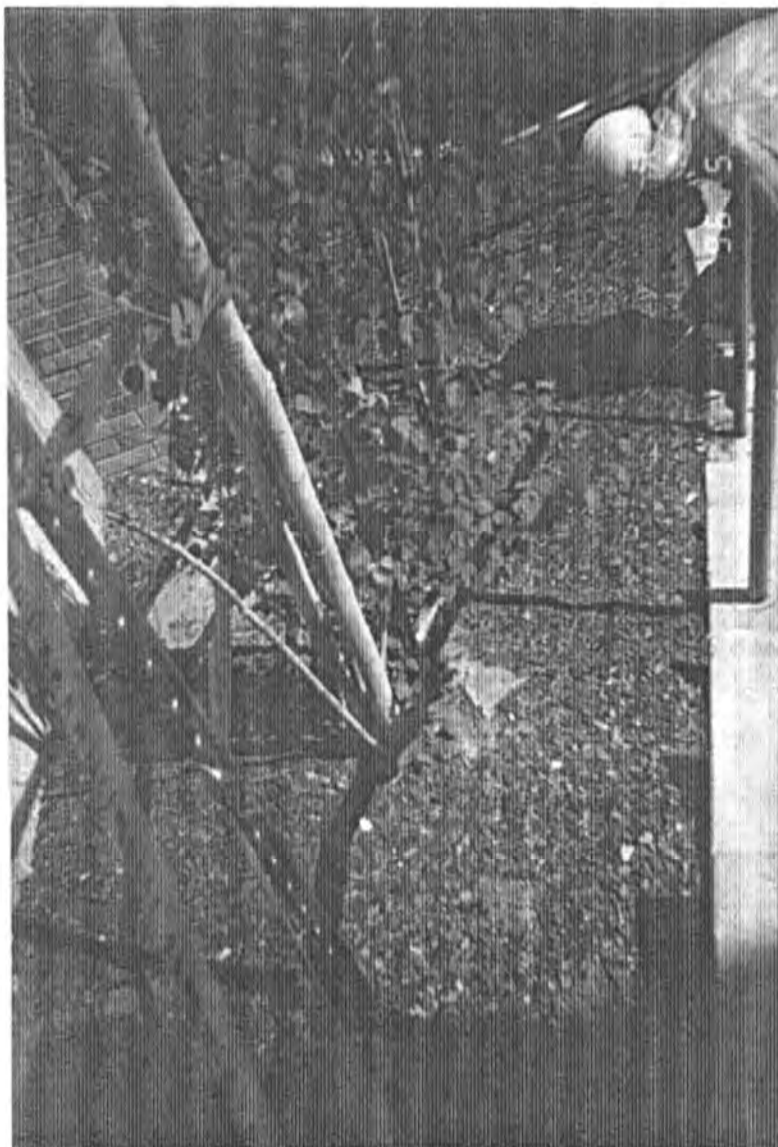
PHOTO 5

Small beads of mercury were noticed in the storm sewer vault, concrete stairway, and lawn adjacent to the concrete stairs (Photos 2 and 5). The concrete staircase for Building 19, leading up to Apt. 203, was cleaned (Photo 9). The extent of mercury contamination was severe along the steps within a major crack of one step, in the surrounding grass, and in the woodchips to the

START personnel conducting preliminary air monitoring along woodchips near apartment No. 203 with a Jerome Mercury Vapor Analyzer.

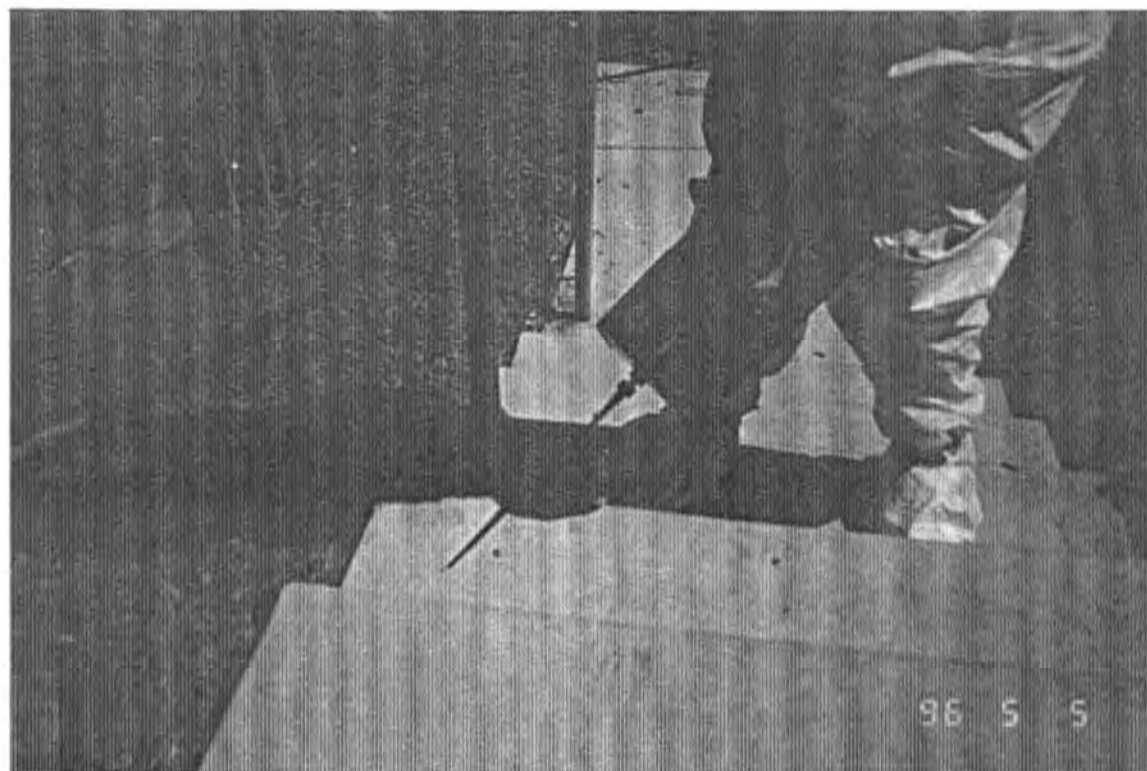
PHOTO 6

A Jerome Mercury Vapor Analyzer Model 431-X was used to screen the indoor air quality and ambient air quality within potentially contaminated areas (Photo 6). Mercury vapor concentrations were detected above the instrument detection limit of 0.0003 mg/m³; therefore, EPA OSC, Pete Stevenson, requested more definitive air monitoring.

START personnel surveying mercury contamination along concrete steps leading to Apt. 203, Building 19, with Jerome Mercury Vapor Analyzer.

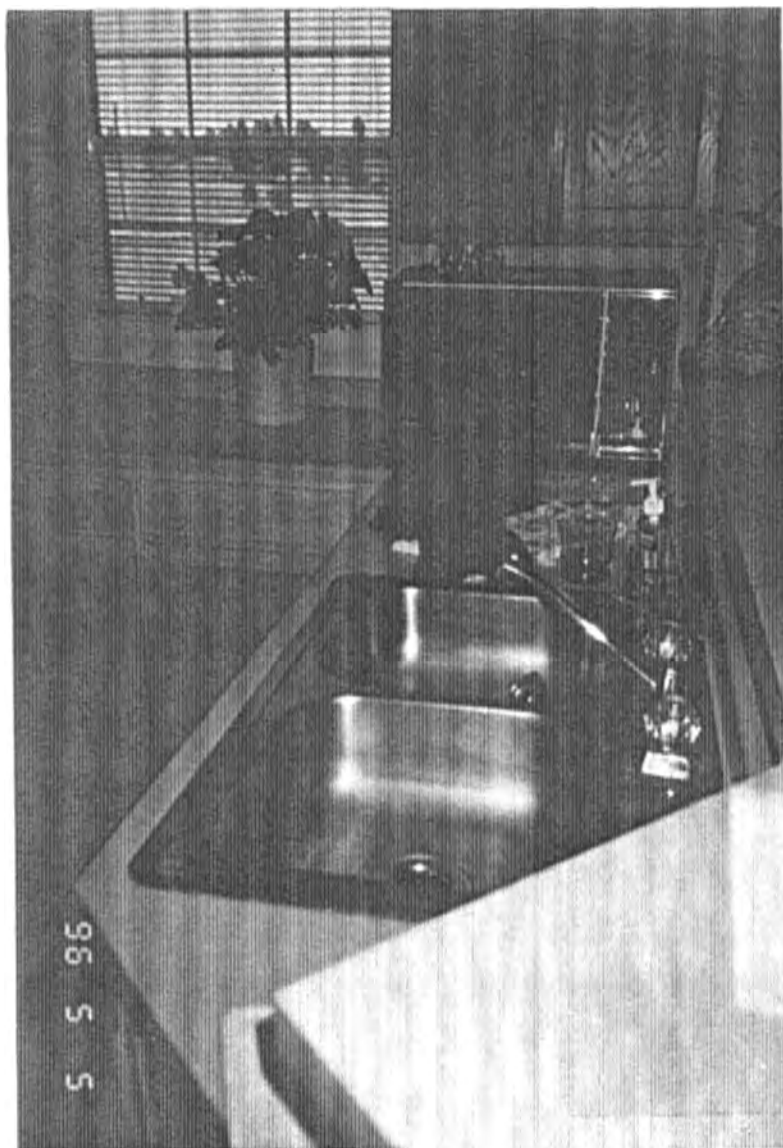
north of the steps (Photo 5). Beads of mercury were noted in the garbage disposal and sink in Apt. 203 (Photo 7).

PHOTO 7
 Kitchen in Apartment 203. Free
 standing mercury observed in sink,
 garbage disposal, and trap.

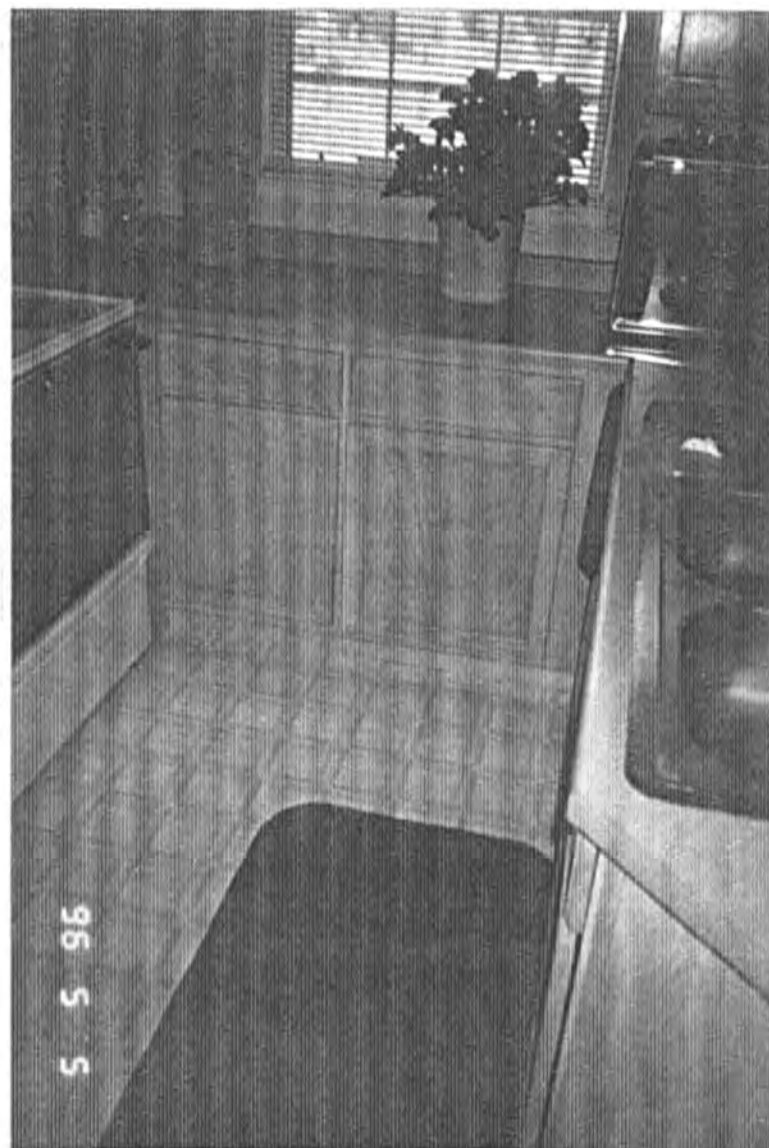
PHOTO 8
 Kitchen of Apartment 203, Building 19.
 Note: Apartment had been cleaned prior to survey.

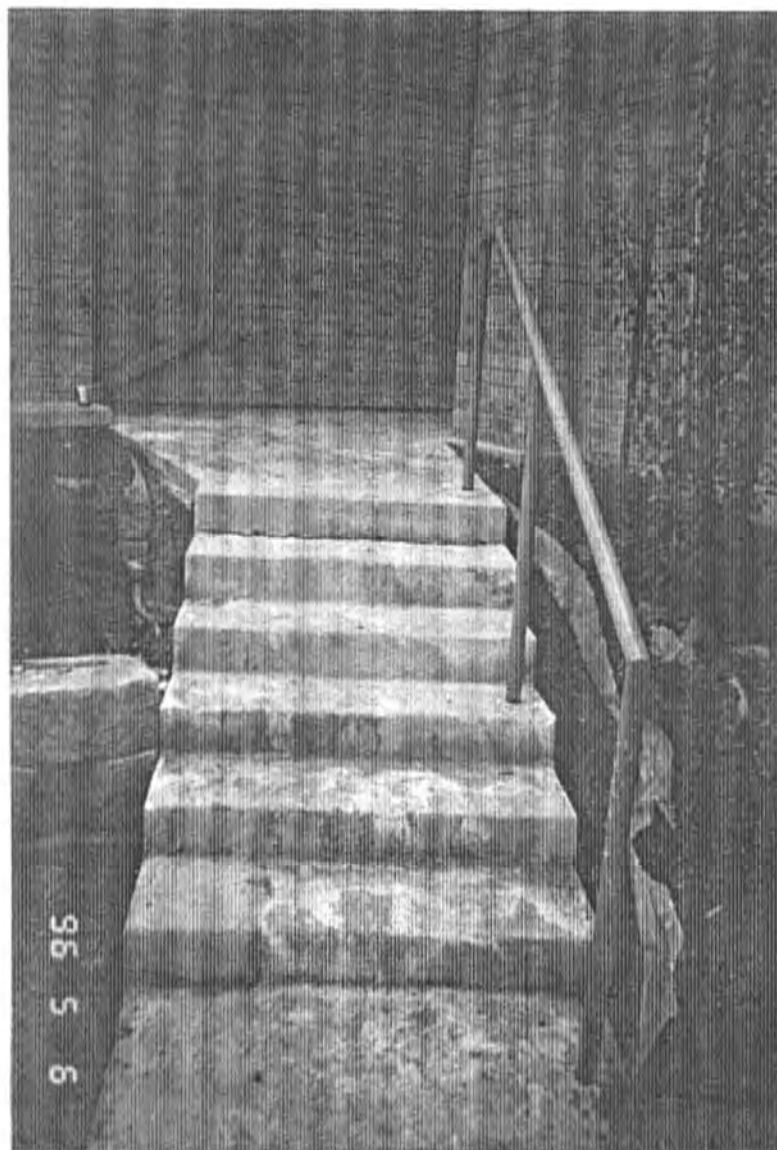
PHOTO 9

Concrete steps leading to Apt. 203 after mercury had been vacuumed. Major crack on top step contained most of the mercury. Woodchips/landscaping had extensive mercury contamination as well. Not all the mercury could be removed.

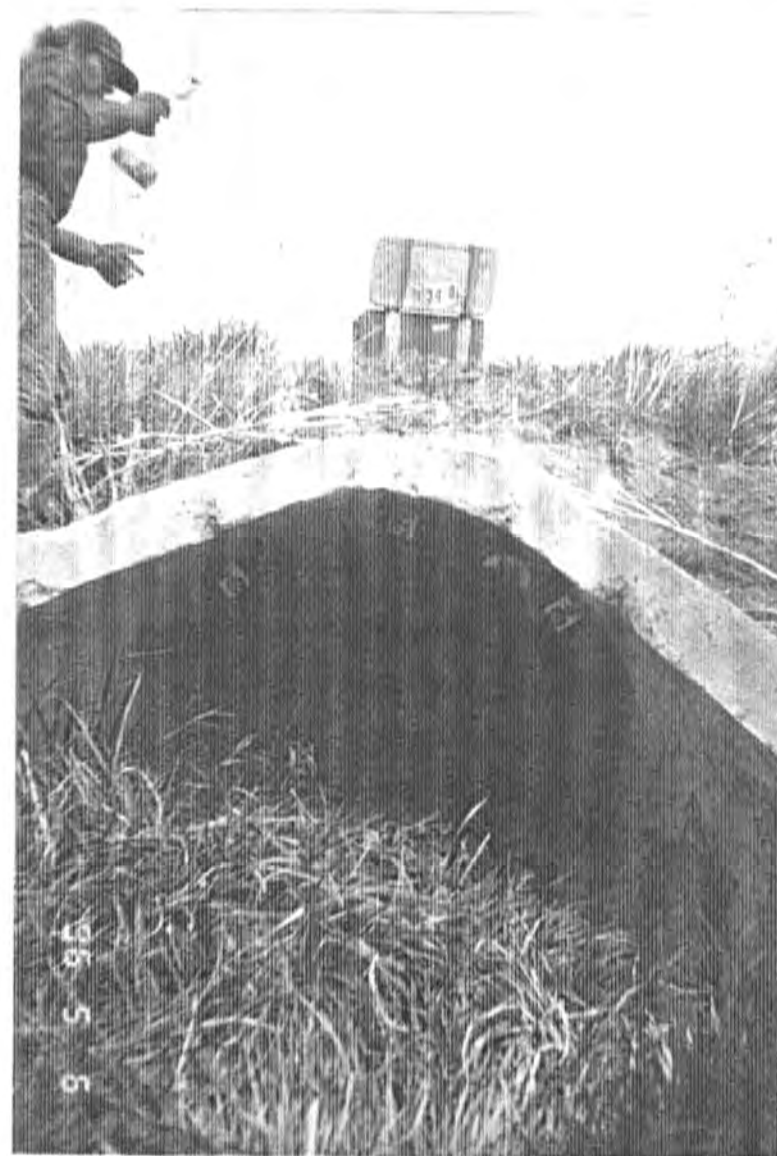
PHOTO 10

sample results (shown in Table 3) indicate a reduction in elemental mercury concentrations following cleanup efforts along the concrete stairs and within the storm sewer vault; CL-SO-01 decreased from 8.836 ppm to 0.985 ppm. The mercury concentration of the sediment samples taken from the west side of the culvert drainage were (CL-SE-01) 14.50 ppm and (CL-SO-13) 3.40 ppm after cleanup; sediment samples collected down gradient and outside of the actual culvert (CL-SE-02 and CL-SE-03) were at or below the laboratory's instrument detection limit of 0.1 ppb (Photos 10, 11, and 12) (Appendix B, Analytical Results).

West end of culvert opening. Sample location CL-SE-01 inside edge of culvert. This is where adolescent males entered culvert which connects to vault (left side).

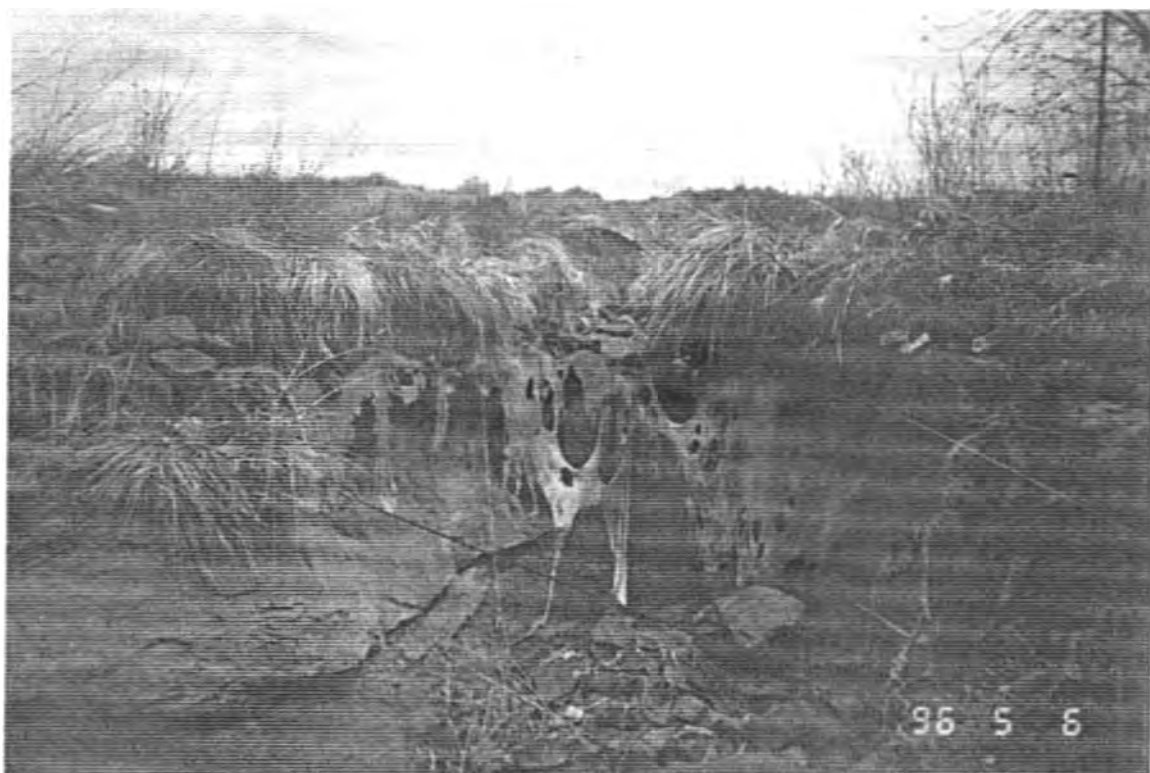
PHOTO 11

Sample location CL-SE-02; drainage channel from west end of culvert.

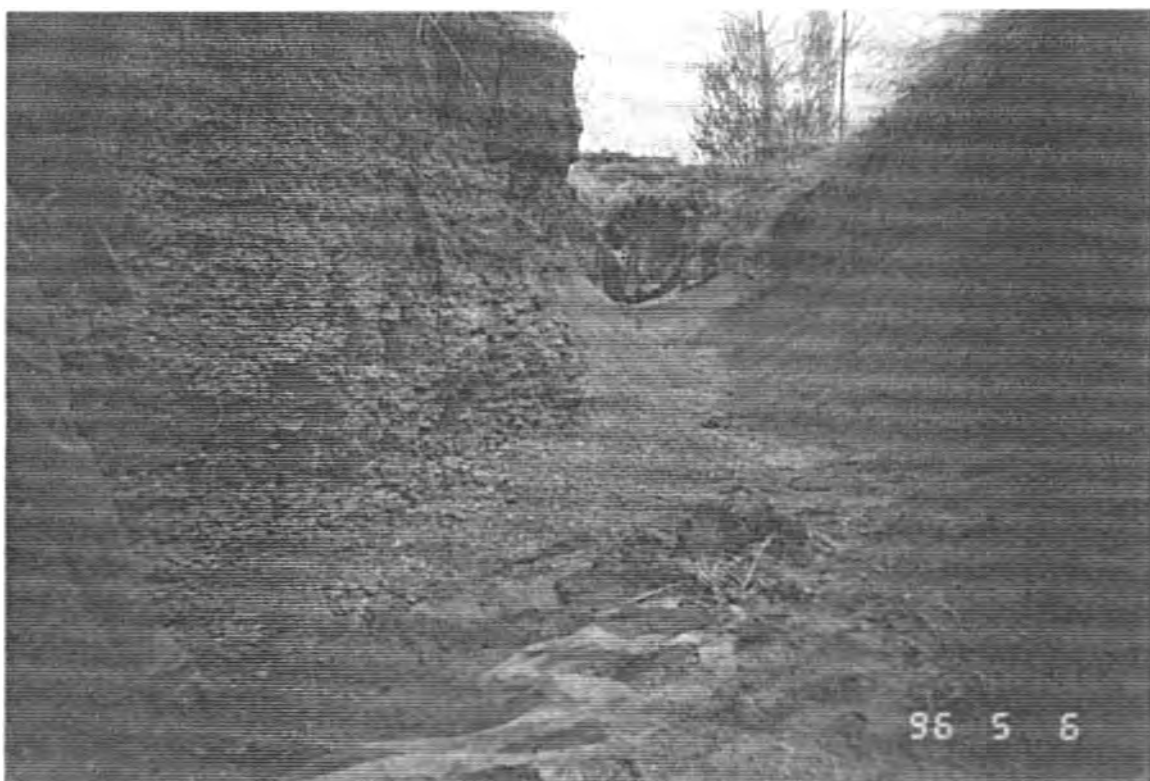
PHOTO 12

Sample location CL-SE-03; drainage ditch from west end of culvert.

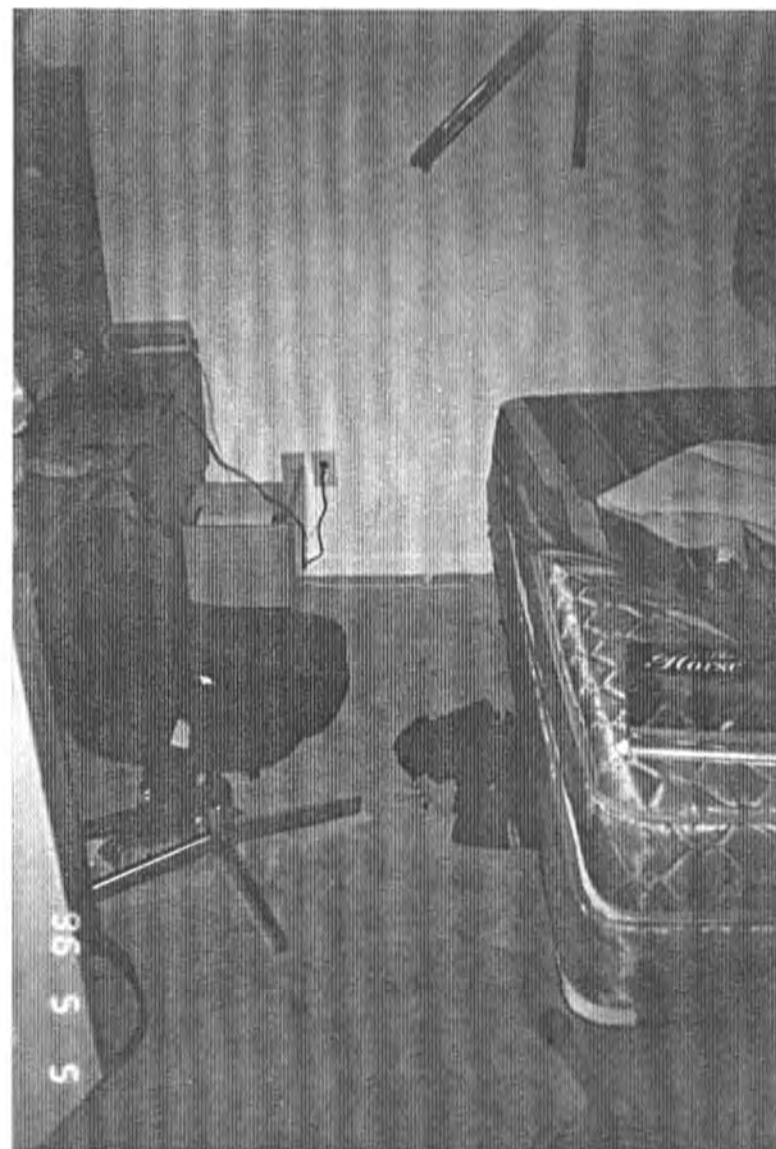
PHOTO 14

Apt. 103 appeared to have more significant contamination, as fine mercury beads were visible throughout the carpet. The adolescent's bedroom in Apartment 103 had extensive visual mercury contamination on the desk, chair, dresser, carpeting, and television (Photos 13, 14, and 15). Some small beads of mercury were located in the living room on the floor, coffee table, and couch.

Apartment 103, bedroom of adolescent. Extensive mercury contamination on carpeting, desk, desk chair, bed, and clothing.

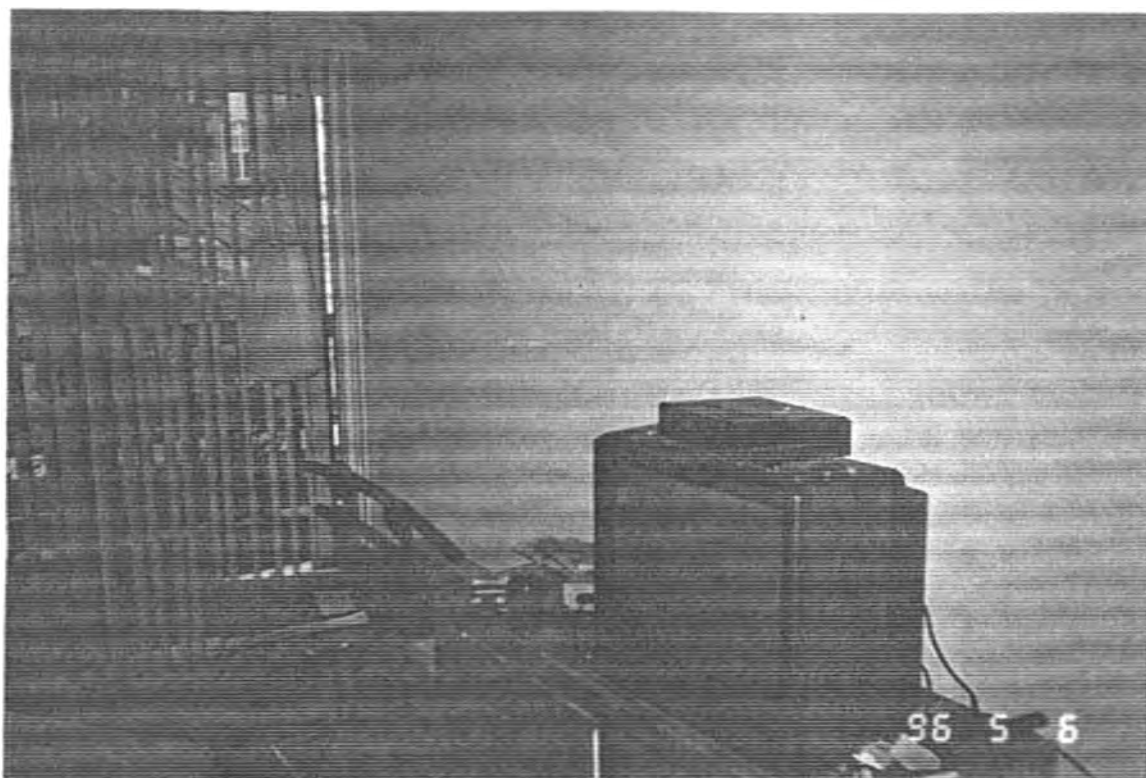
PHOTO 15

Bedroom of adolescent in Apt. 103. Mercury beads were found in some of the drawers in the dresser.

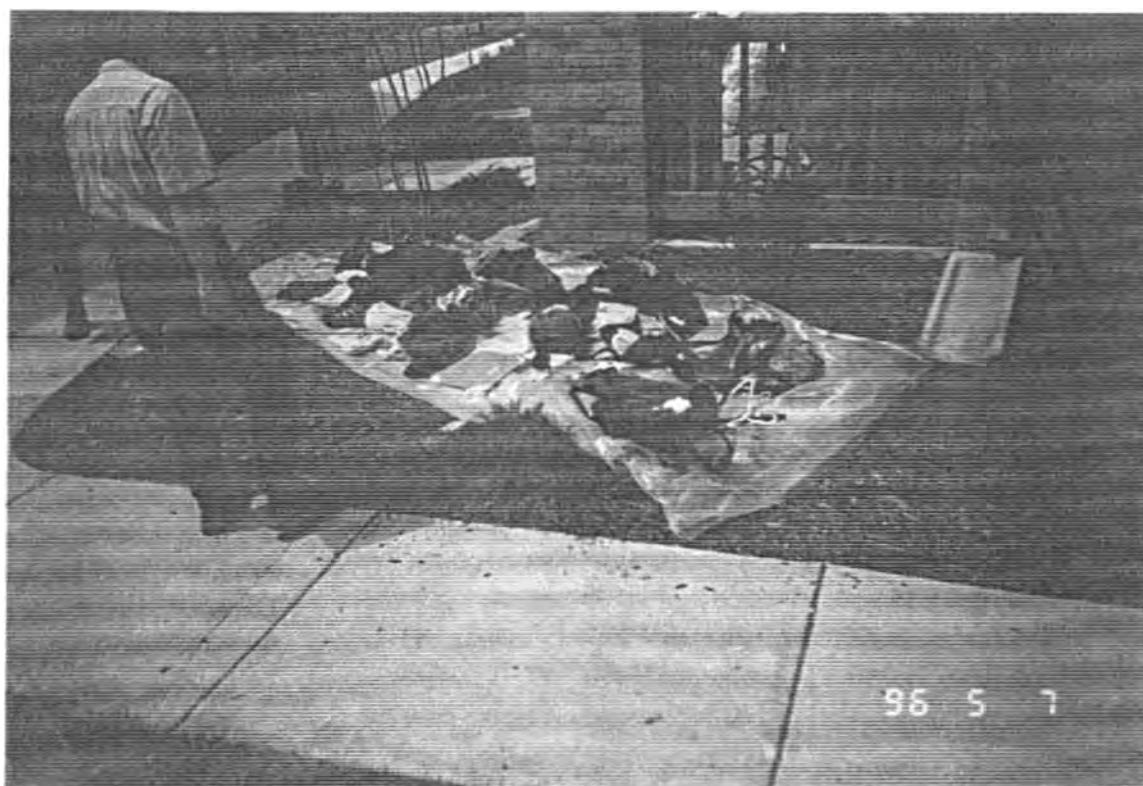
PHOTO 16

START personnel monitoring mercury vapor concentrations after belongings had been aired out in front of Apartment No. 103.

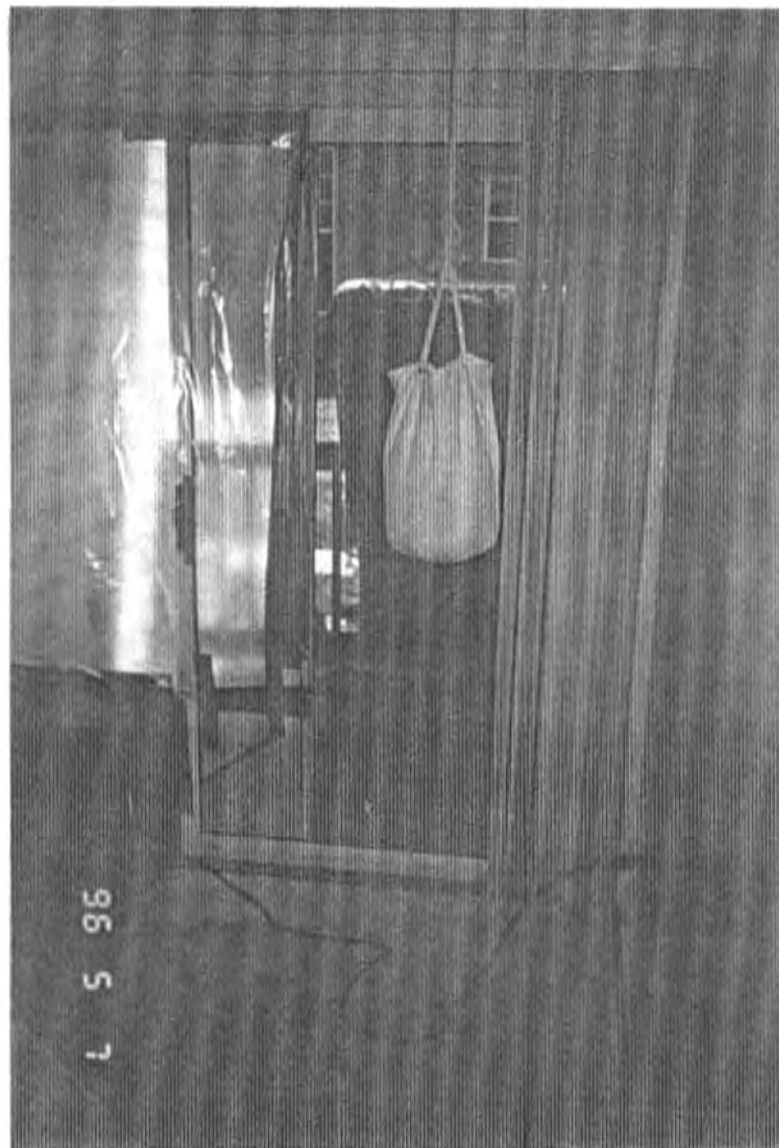
PHOTO 19
 Apartment 103 bedroom of adolescent
 being aired out after carpet removal.

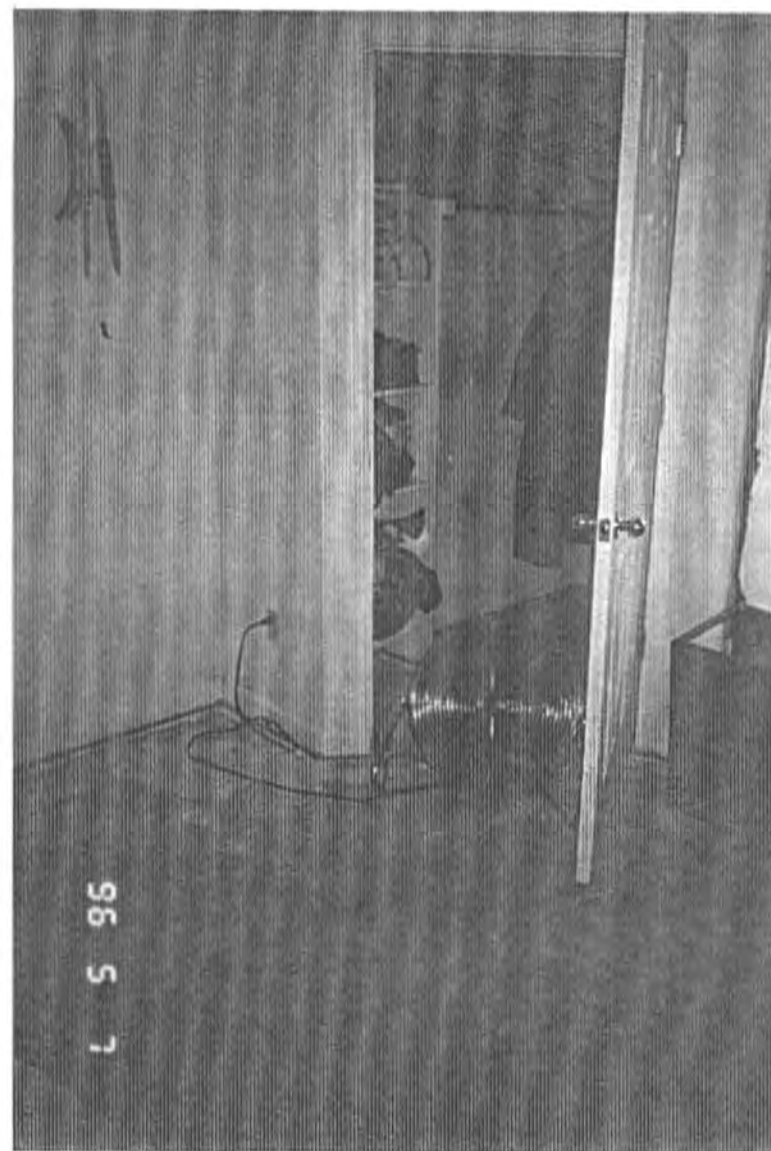
PHOTO 20
 Apartment 103, adolescent's
 bedroom closet being ventilated.

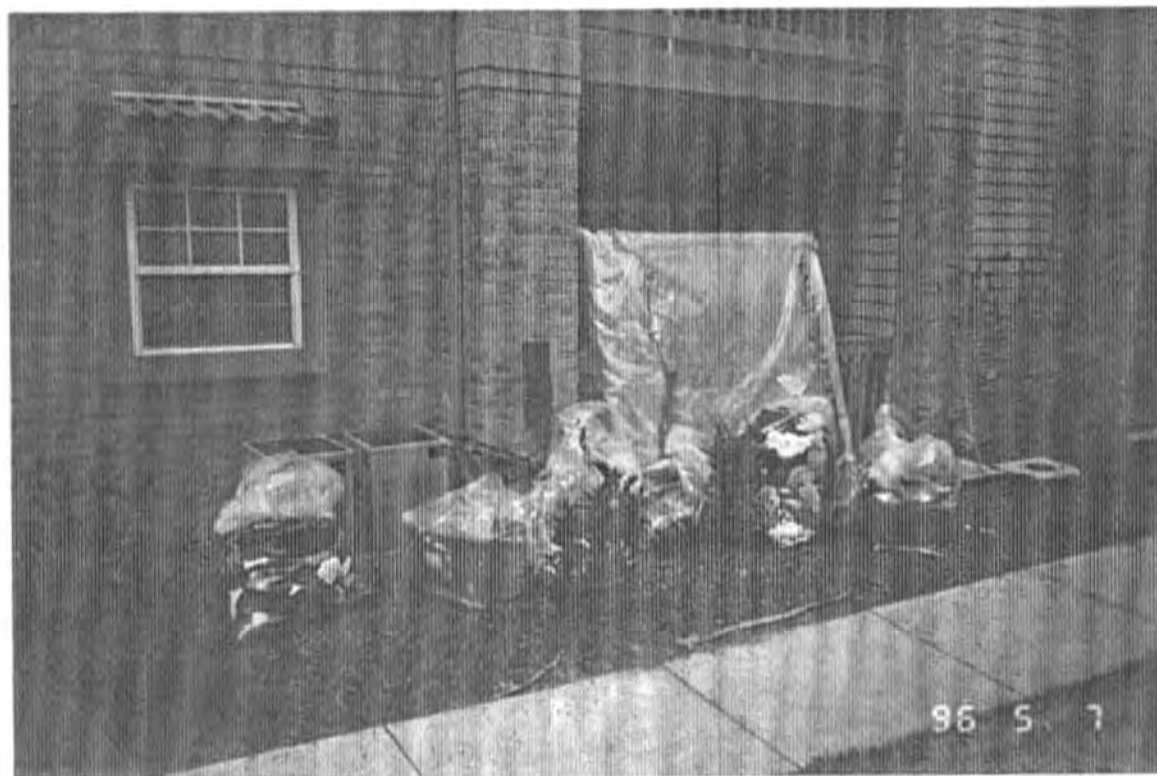
PHOTO 21

Bagged items from Apartment 103 for disposal after ventilation efforts were unsuccessful in lowering mercury vapor concentrations.

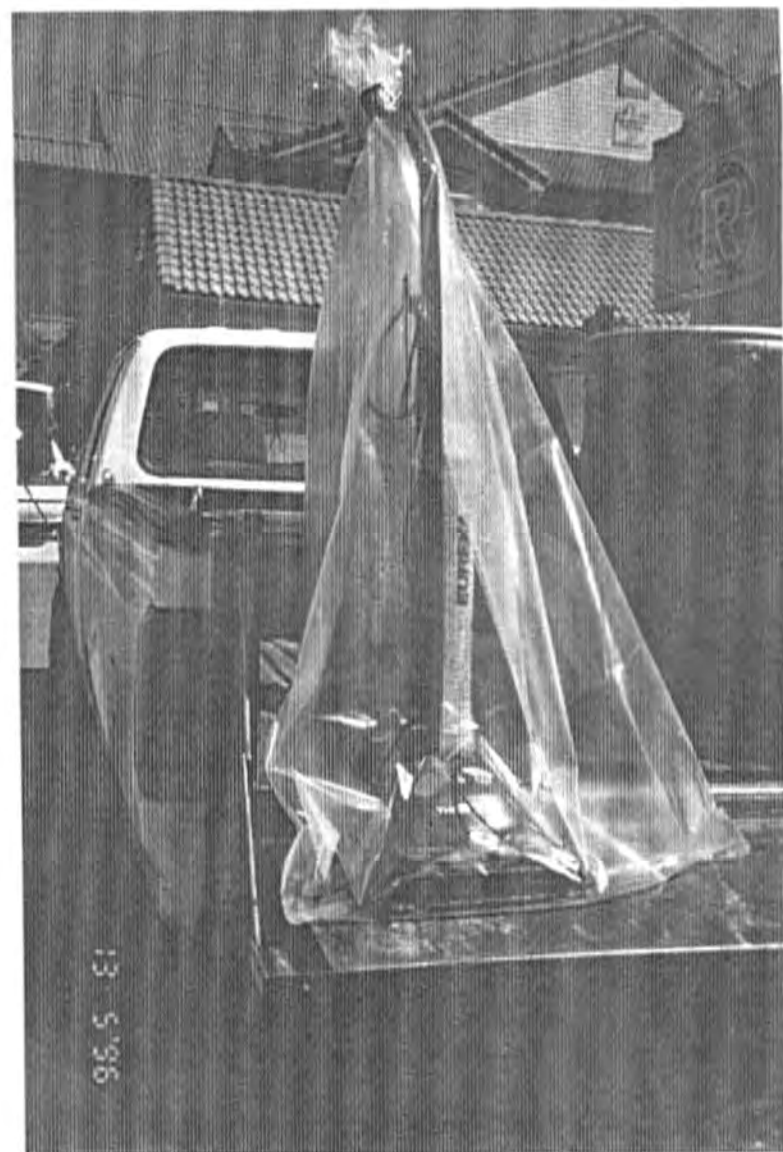
PHOTO 22

Vacuum cleaner to be disposed of. Mercury vapor concentrations were too high for residents to keep.
